United States Department of the Interior

BUREAU OF LAND MANAGEMENT

Date: 08/20/10
To: Minerals Files UTU-69800, UTU-69812
From: Ted McDougall, Geologist
Subject: Surface Management Site Inspection, Denison Mines (USA) Corp, La Sal Mines (Pandora – UTU69800/M0370012; LaSal, Snowball and Beaver– UTU69812/M0370026), San Juan County, Utah.

Date of Inspection: 08/16/2010
Time of Inspection: 9:00 A.M.
Participants: Ted McDougall, Danny Flannery
Legal Description: T. 29 S., R. 24 E., Section 01
Claimant/Operator: Denison Mines
Bond Amount: \$175,811 for Pandora Mine
Date of Last Bond Review: 10/19/09 for Pandora Mine

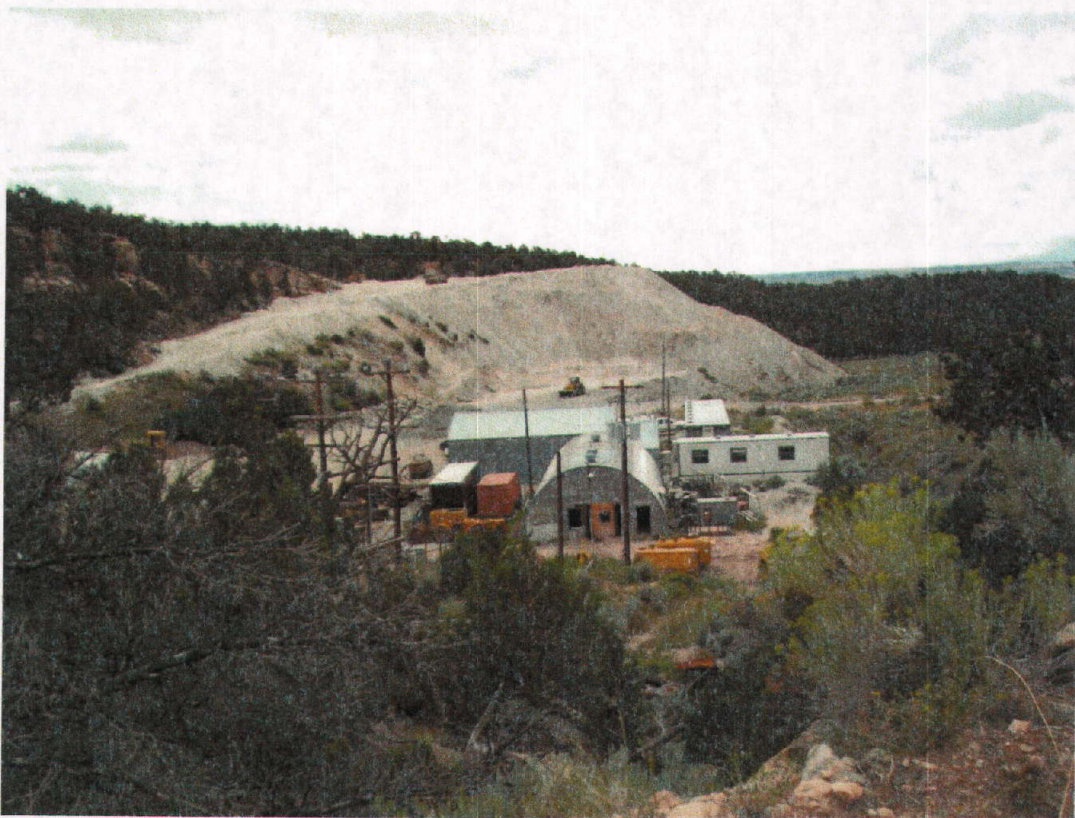
Pandora Mine. Top – Overview of mine; Bottom- Office, shop, dry and warehouse.

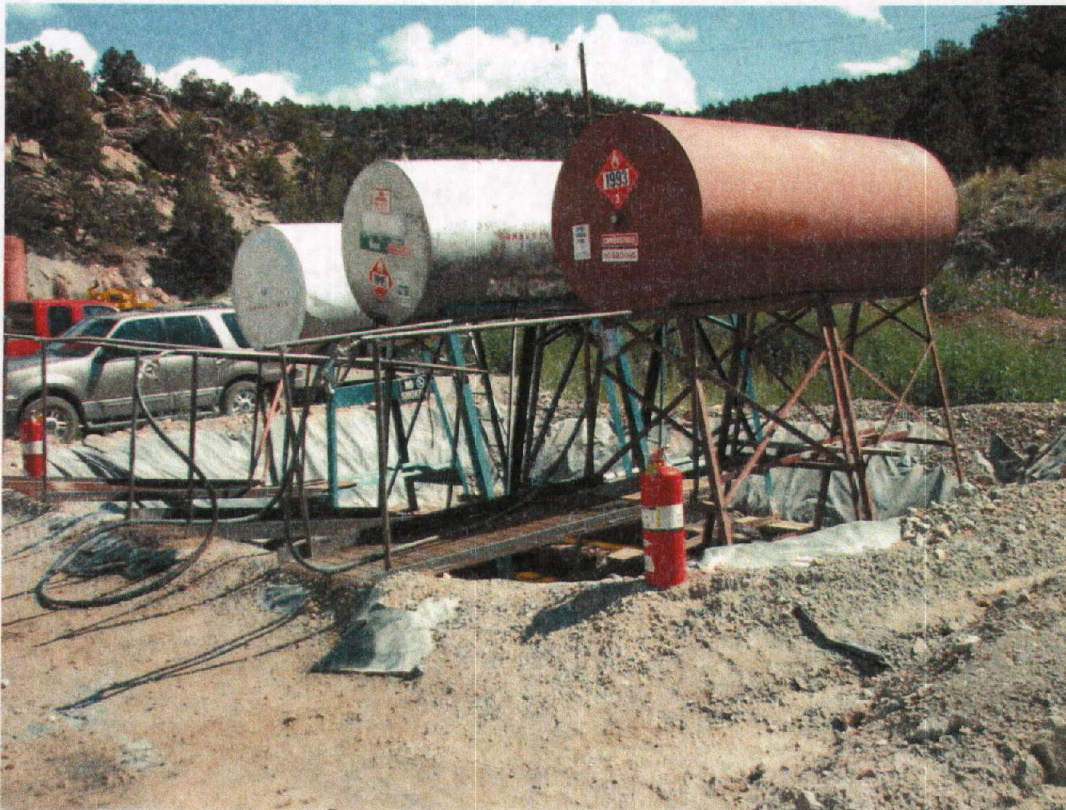
Three fuel storage tanks were observed on site. The tanks are contained by berms and a synthetic liner. The containment is designed to hold at least 1 ½ times the volume of the largest tank.

Pandora Mine. Top – Fuel storage tanks within containment area; Bottom- Mine portal.

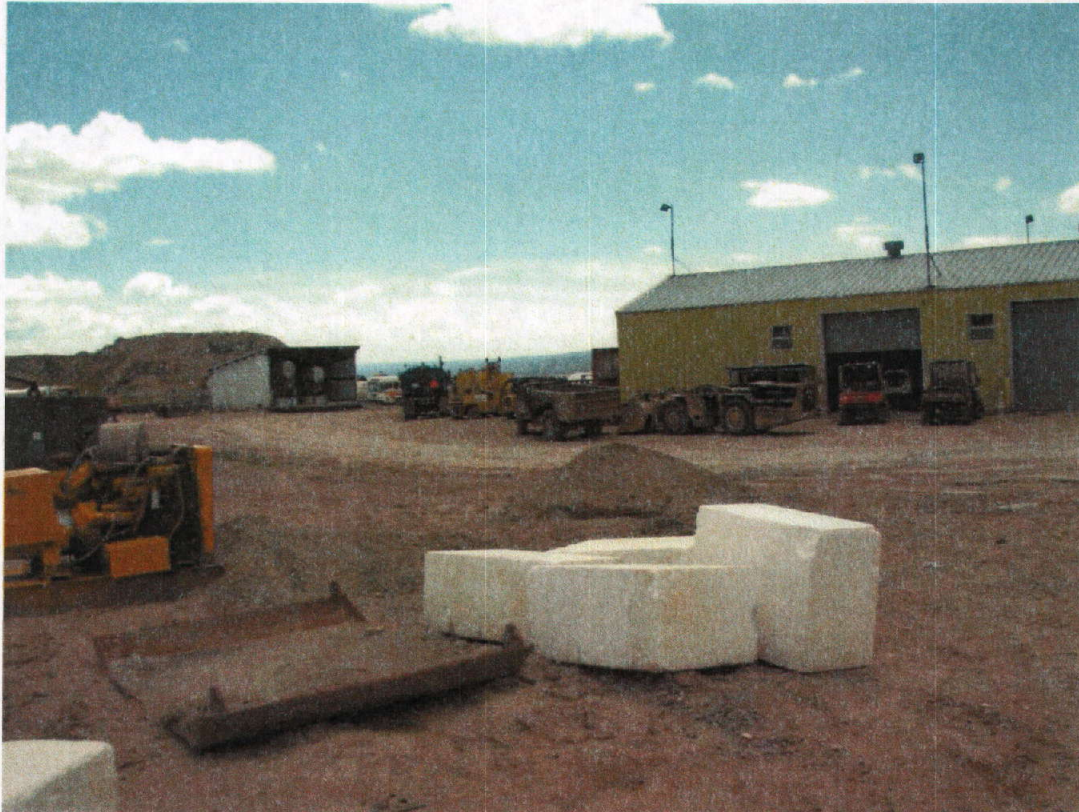
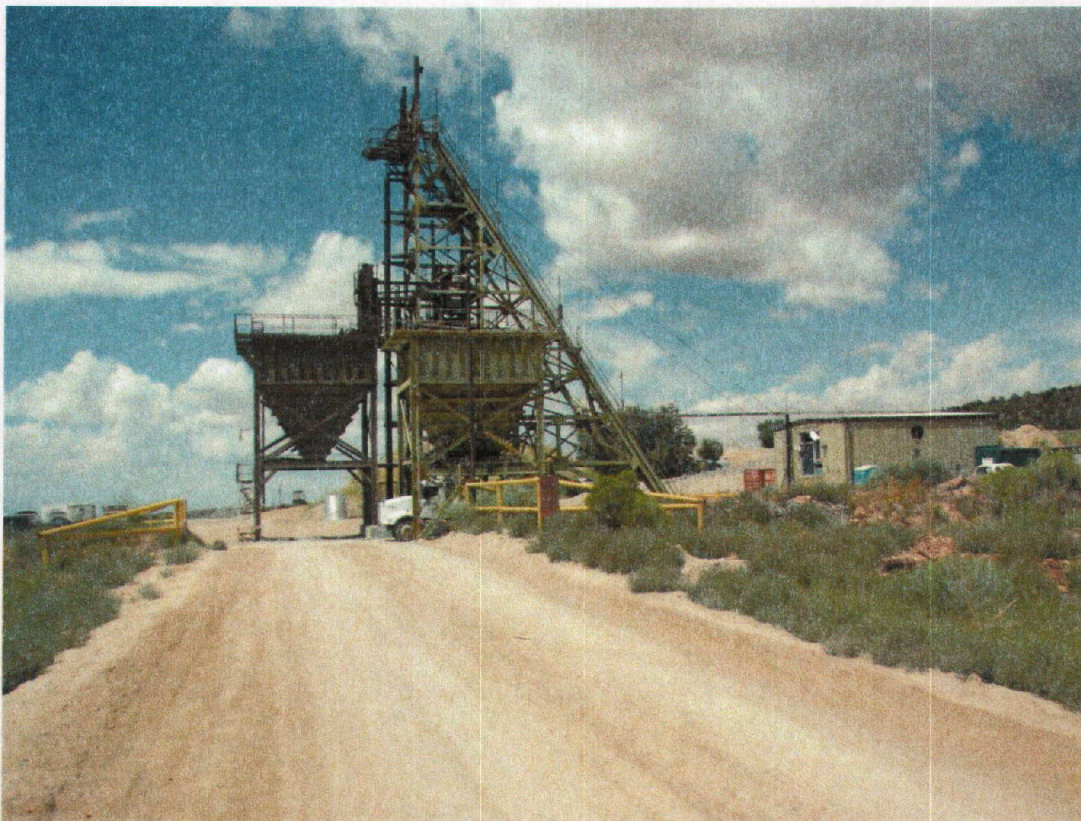
Uranium ore is currently being produced at the Beaver Shaft. Unlike the other mines in the LaSal Complex, the ore is hoisted to the surface through a shaft. Mine facilities occur on both private and BLM land. Based on a map prepared by Denison Mines, it appears that the east waste rock dump is entirely on BLM as well as a portion of the west dump. As with the other mines visited, no catchment basins were noted at the dumps to contain storm water runoff.

Beaver Shaft. Top – Head frame and hoist house; Bottom – West waste rock dump.
